BMW 428i xDrive Coupé Modern Line

03/2015, 180,026 km

Paint readings 04.11.2026, mileage as of 07.10.2026

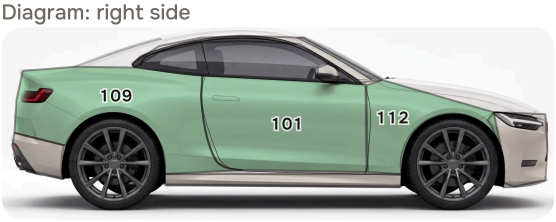
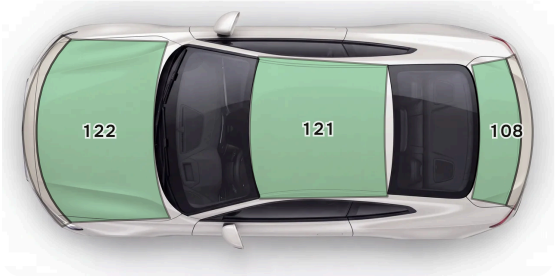
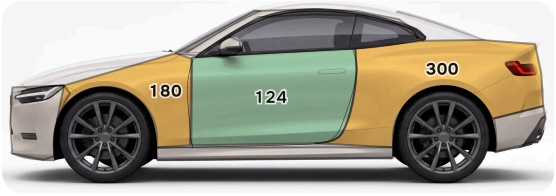
Paint per panel, measured on 04.11.2026

Rear left quarter panel From 180 to 300 µm on this panel	Repainted	**300 µm**
Front left wing	Repainted	**180 µm**
Left door		**124 µm**
Bonnet		**122 µm**
Roof		**121 µm**
Front right wing		**112 µm**
Rear right quarter panel		**109 µm**
Boot lid		**108 µm**
Right door		**101 µm**

Up to 160 µm within factory paint range. 161 to 300 repainted. Over 300 filler.
